# ADDENDUM TO DESIGN MEMO 4.11

### Curved Roadway Example

THE CITY OF  
**COLUMBUS**  
 ANDREW J. GINTHER, MAYOR  
 DEPARTMENT OF  
 PUBLIC SERVICE

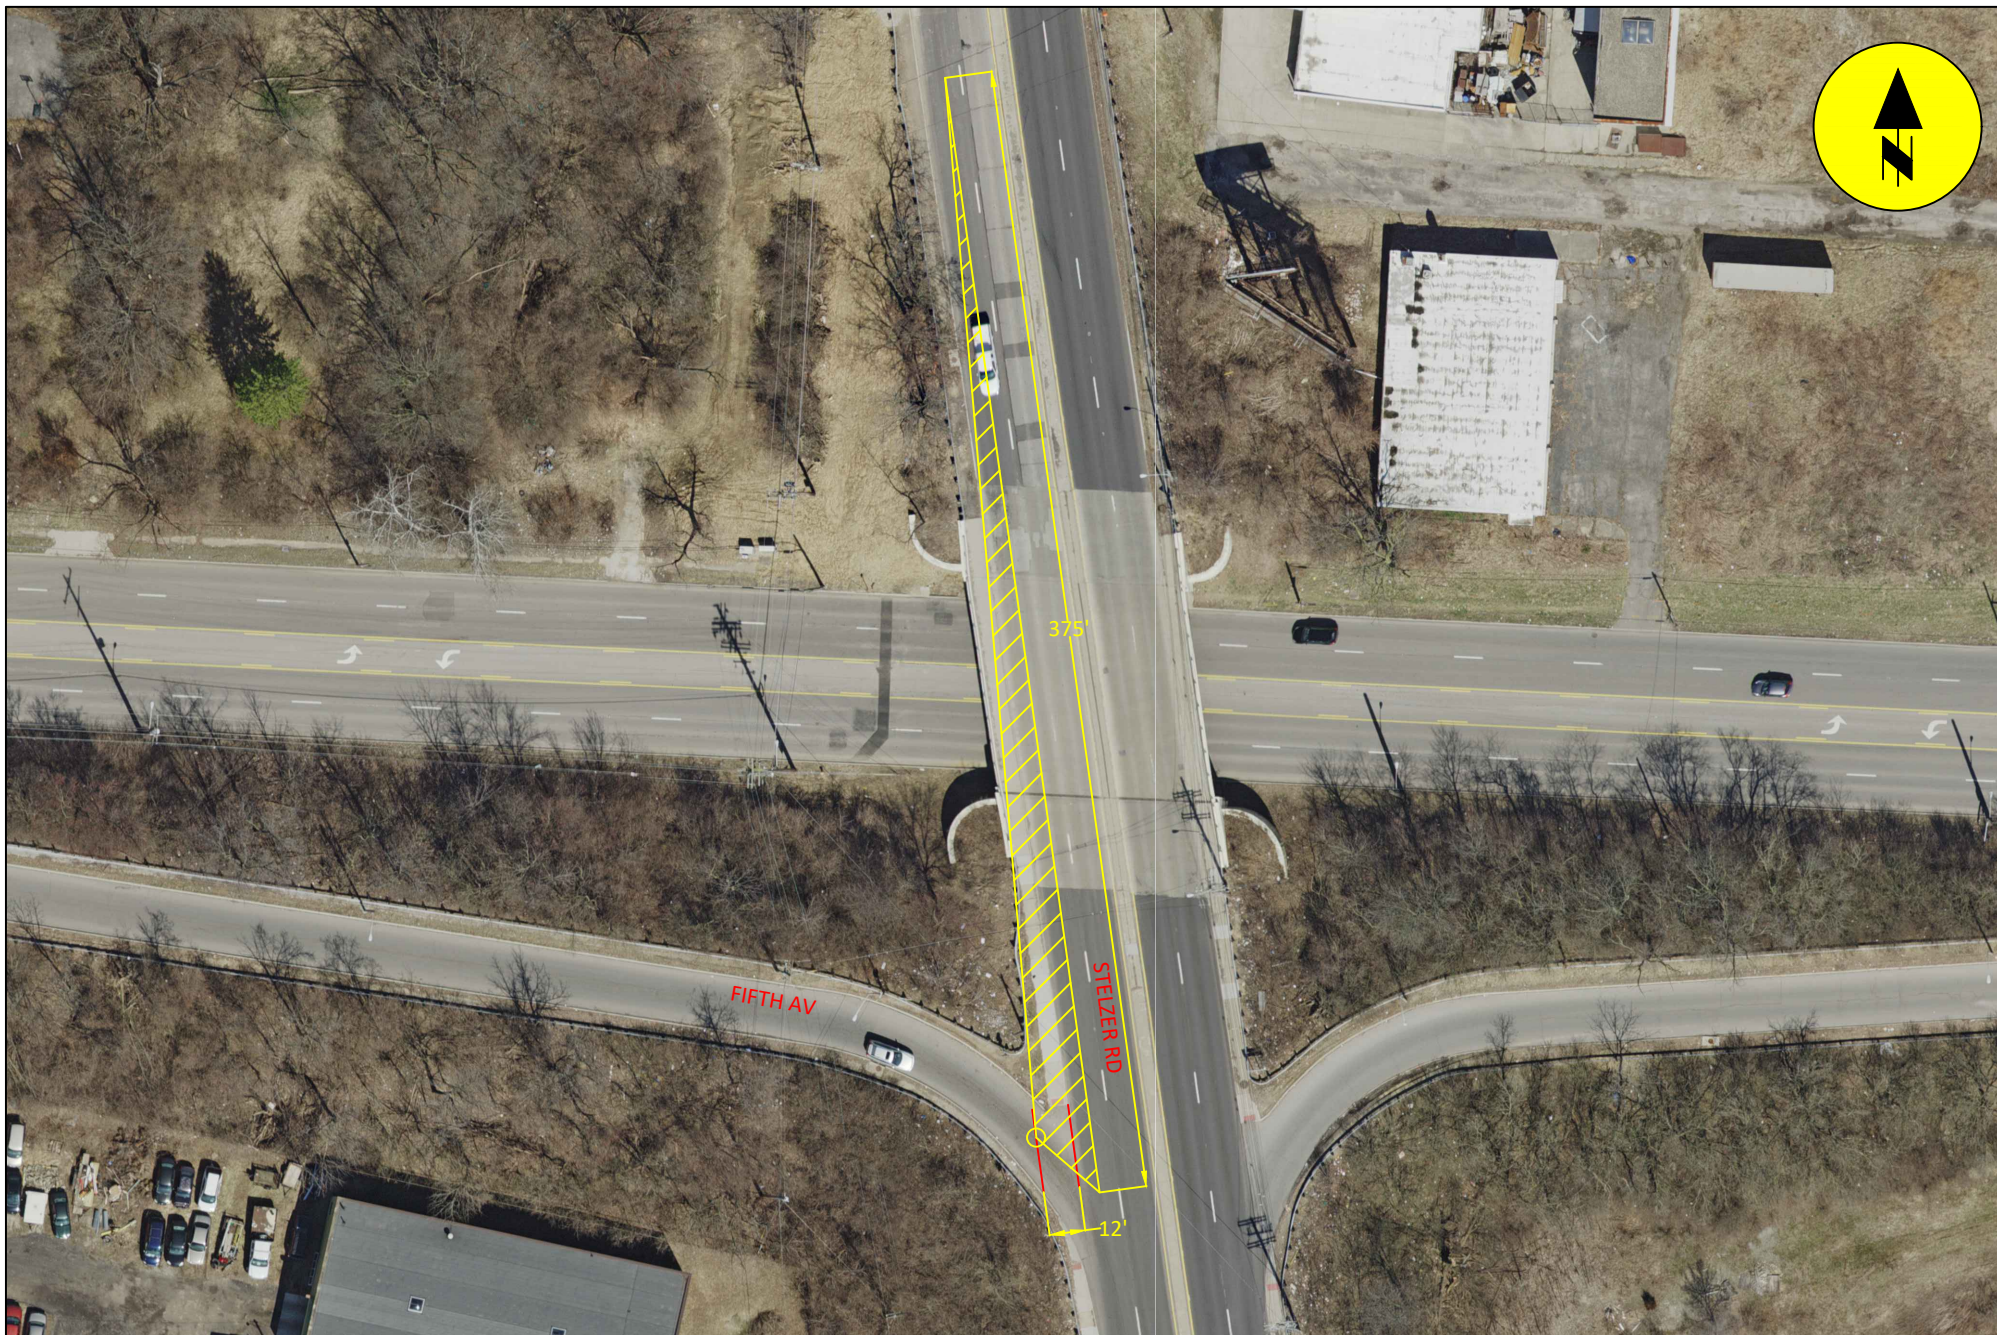
SIGHT DIST TRIANGLE

FIFTH AV @  
STELZER RD

RIGHT TURN EXAMPLE

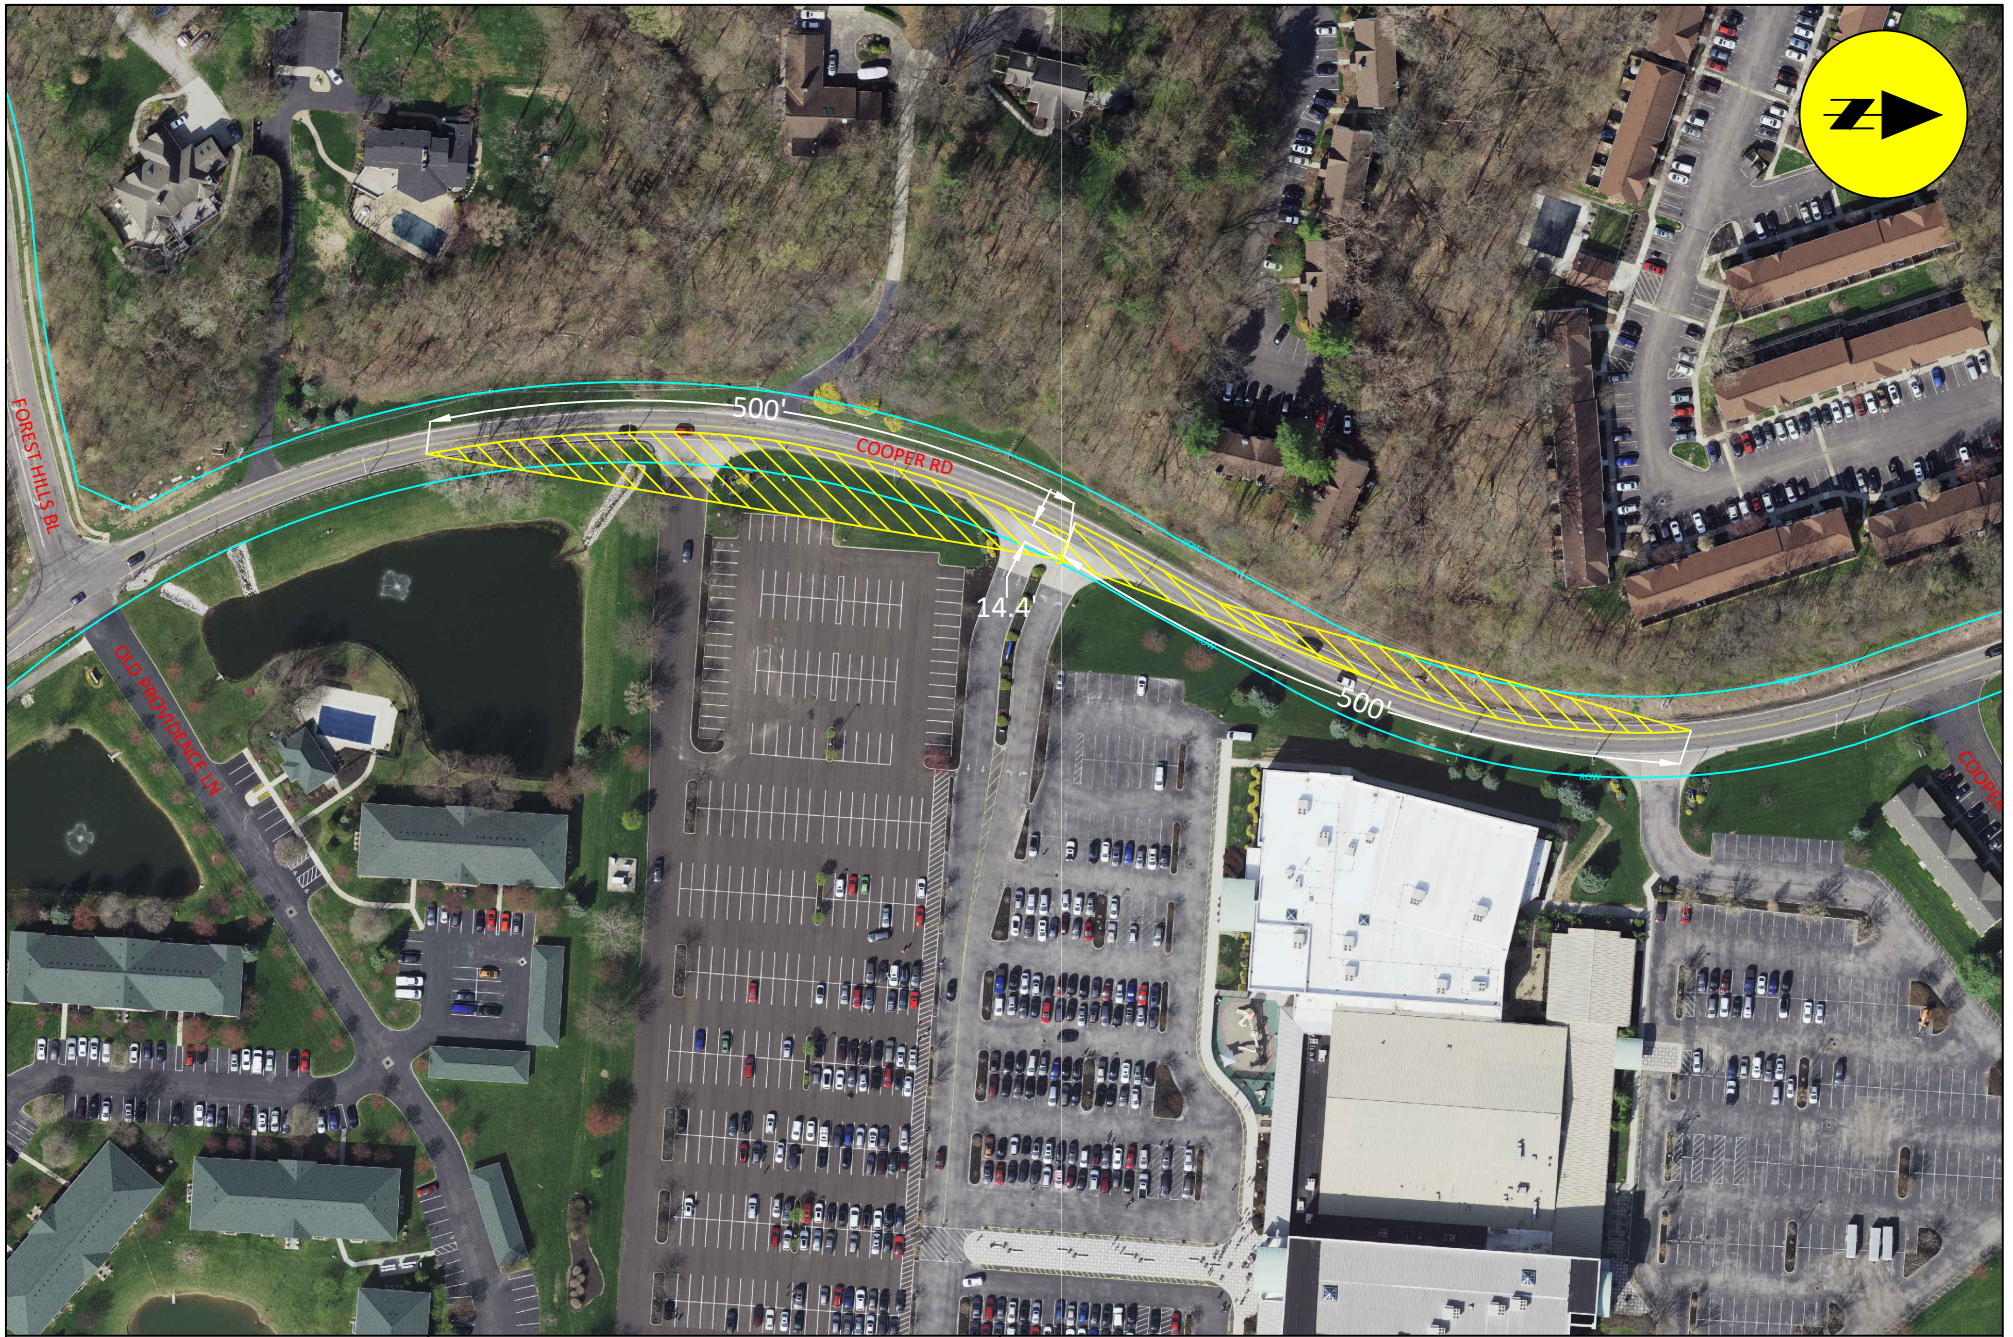
SIGHT DIST TRIANGLE  
 COOPER RD @  
 MIDDLE DRIVE LEFT

LEFT TURN ON CURVE EXAMPLE  
 TRAFFIC MANAGEMENT

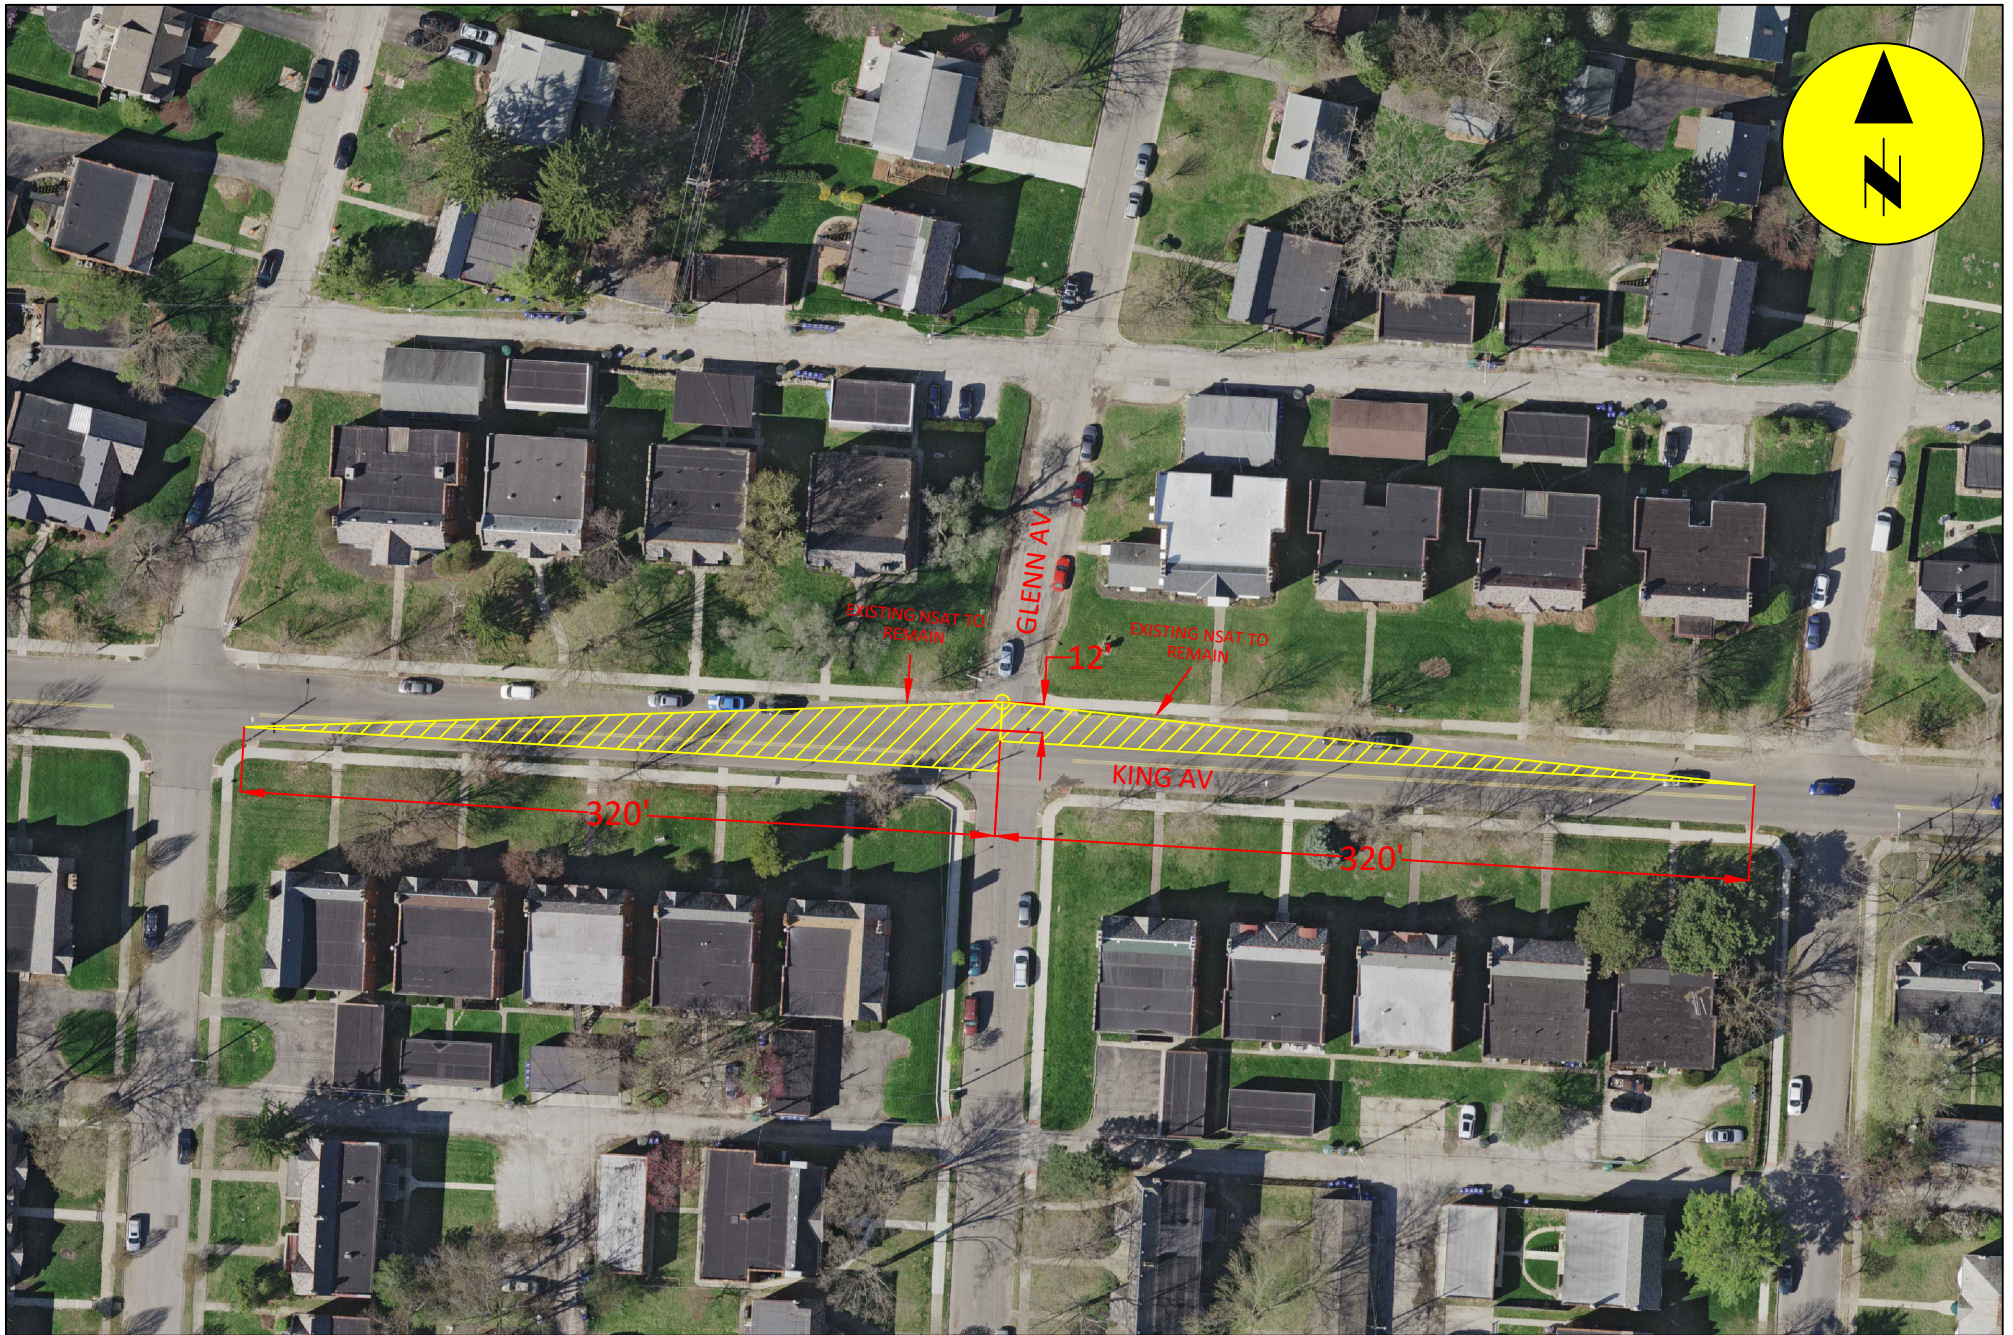
SIGHT DIST TRIANGLE  
 KING AV @  
 GLENN AV (SB)

PARKING PRESERVATION EXAMPLE  
 TRAFFIC MANAGEMENT

A lack of angle crashes in the SB approach suggest that vehicles parked within the SB SDTs (see page 7) do not present serious sight distance issues for SB drivers at this intersection. In this case, engineering judgment led to a decision to preserve existing on-street parking.
